**PROFESSIONAL STANDARDS BUREAU
PERSONNEL COMPLAINT TRACKING**

ALLEGATION: Critical Incident (Troop Car/Pedestrian SPII)

SYNOPSIS: On 08/14/2018, Tpr Distasi was involved in a Troop Car/Pedestrian SPIAA while operating 3F28 on North Rd on the Town of Lloyd, Ulster County. This investigation concluded that the cause of the accident was pedestrian error on part of the pedestrian, [REDACTED]. This investigation revealed no violations of NYSP Rules or Regulation on part of Tpr Distasi.

Division Vehicle (3F28) - Pedestrian Injury Collision
 North Road
 Town of Lloyd
 Ulster County
 August 14, 2018 - 5:58 A.M.

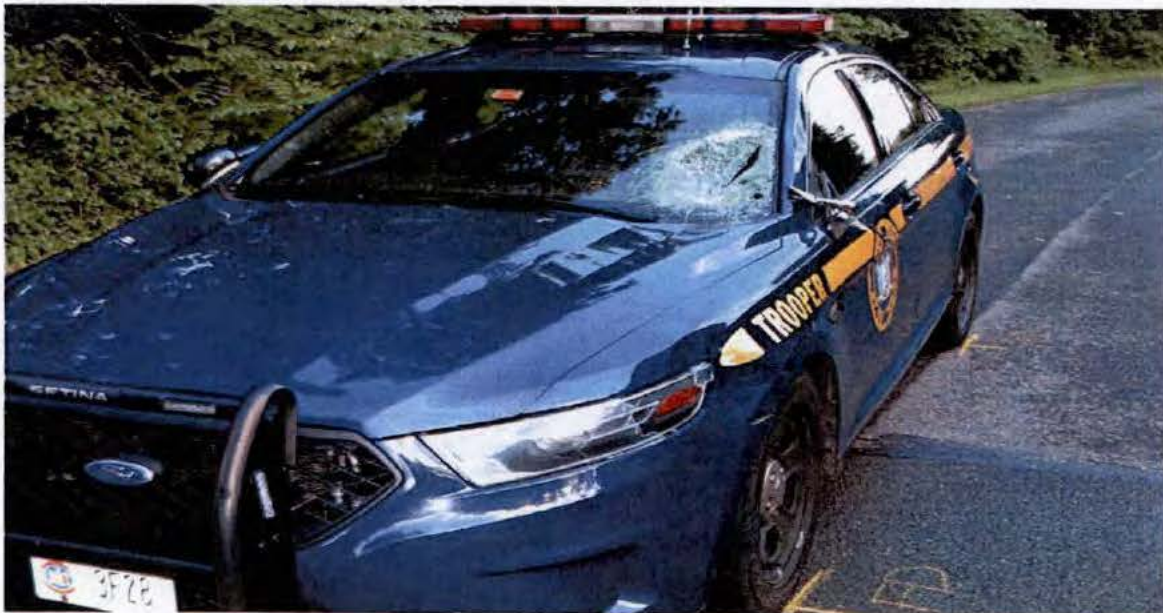
Vehicle #1 at Scene

A pedestrian who was identified as [REDACTED] with a D.O.B. of [REDACTED] was walking northbound on North Road in the center of the roadway. Vehicle #1 struck [REDACTED] with the left front fender and headlight assembly. After being struck, [REDACTED] subsequently strikes the lower left corner of the windshield, driver side "A" pillar, side mirror and spot light with his upper body. Following the collision, Vehicle #1 came to a position of controlled final rest within the southbound lane of travel. After being struck, [REDACTED] was projected and came to a position of un-controlled final rest in a grassy area adjacent to the northbound lane of travel. [REDACTED] was transported to Mid-Hudson Regional Hospital in Poughkeepsie, New York for medical treatment. The operator of Vehicle #1 was transported to First Care Walk – In Medical Center in Highland, New York for medical treatment.

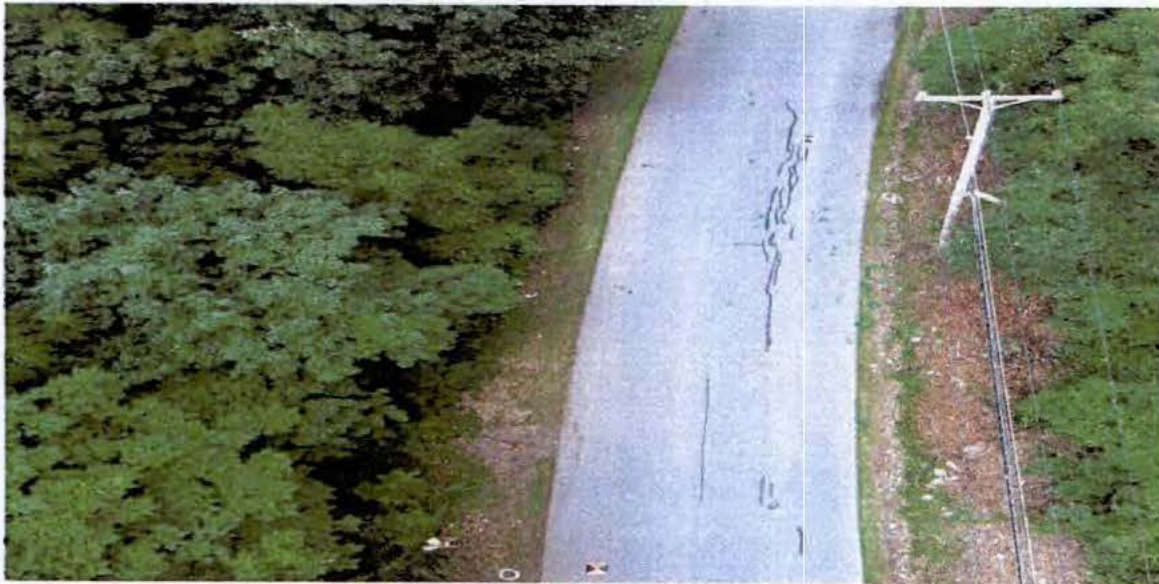
North Road Facing North

North Road, in the area of the collision was an unlit, two-lane, individual flow roadway oriented in a southwest-northeast direction. For report clarity, the roadway direction will be described as it if were oriented south to north. There was no centerline marking on the roadway to divide southbound and northbound traffic. The roadway was constructed of asphalt and was moderately traffic polished. The area surrounding the collision scene consisted of a wooded area to the east and west, along with several residential properties to the south. The roadway in the area of the collision curved to the left, and there was no pedestrian signage or roadway paint designating a pedestrian crosswalk or regulated crossing area. *(Refer to attached scaled diagram for scene evidence descriptions and locations).*

At the time of the collision, [REDACTED] was wearing two separate tee shirts, one shirt was dark blue and the other shirt was green in color. [REDACTED] was also wearing black jeans, and black shoes. None of the clothing being worn by [REDACTED] was found to have reflective properties. The possibility of [REDACTED] being seen walking in the middle of the roadway by the operator of Vehicle #1 was also hindered by the lack of artificial ambient light, as well as the weather conditions at the time of the collision. The only source of artificial ambient lighting in the area was located on the east side of the roadway several hundred feet south of the collision scene. The weather at the time of collision was reported to be foggy with cloudy skies, and a wet roadway.
